Sand-Cement Concrete in the Century-Old Camarasa Dam

A. Blanco, Ph.D.¹; I. Segura, Ph.D.²; S. H. P. Cavalaro, Ph.D.³;
S. Chinchón-Payá, Ph.D.⁴; and A. Aguado, Ph.D.⁵

Author keywords: Sand-cement; Concrete dam; Freeze-thaw cycle; Leaching.

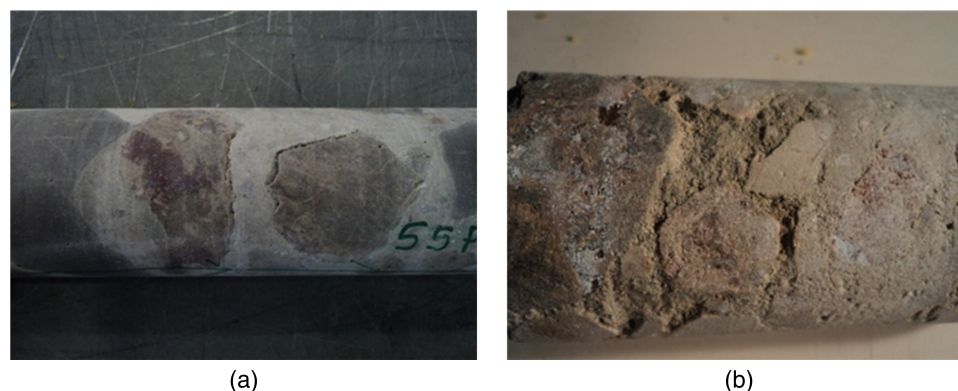
Visual inspection of the cores reveals that the cores extracted from the central area of the downstream face (cores S1, S2, S4, and S5) as well as the core S3 (extracted from the lower areas of the left abutment) exhibit a homogeneous aspect without significant signs of degradation. In some cases, a lack of bond in the aggregate-matrix interface was detected [Fig. 3(a)]. Furthermore, most of the cores exhibited aggregates with pores and cavities, some of which presented crystalline compounds.

Fig. 3. (a) Lack of bond between aggregate-matrix in S5; (b) deterioration in matrix of S8 (reprinted from Conesa et al. 2015, with permission)

The cores extracted from the left abutment of the dam at heights over 275 m (cores S6 and S8), showed more signs of degradation than others. Such degradation was caused by the lack of bond between the aggregate-matrix interface, cracking in the aggregates and the matrix, as well as cavities and green halos around certain aggregates.

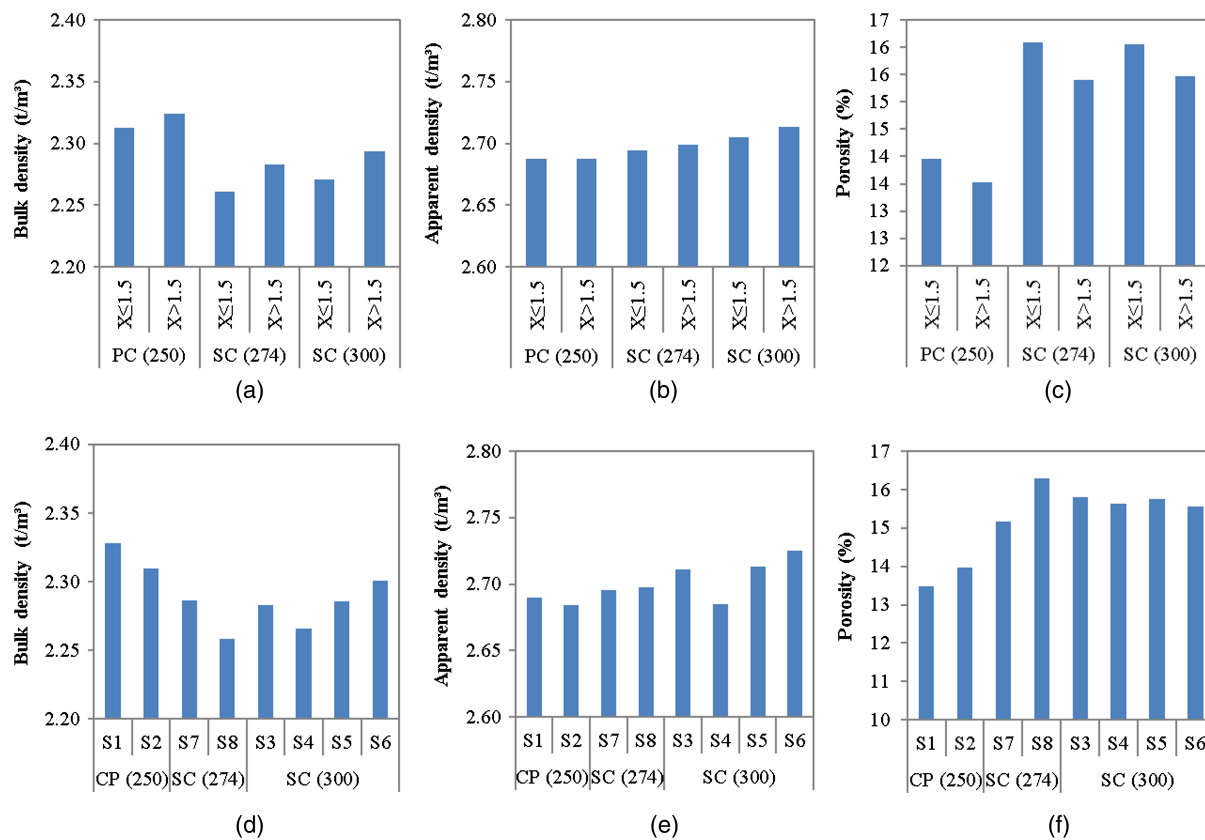
In general, the apparent density in the surface ($X \leq 1.5$ m) is lower than in the inside of the dam, particularly in the case of sand-cement [Fig. 4(a)]. However, no significant differences are observed in the real density with the depth, even though the scatter is smaller [Fig. 4(b)]. This outcome suggests the existence of a degradation process in the external part of the dam, which reduces the apparent density of the concrete. Since the variation does not occur for the real density, the origin of such degradation is unlikely to be chemical but physical. The damage is more evident in the concrete with sand-cement, which is consistent with the state of the downstream face.

The results in Fig. 4(c) verify the existence of a higher porosity in the superficial layers, which leads to the reduction of the apparent density in such areas. This variation may be attributed to the boundary conditions during the construction process or to the material degradation. The first hypothesis is discarded since the depth selected was large enough with respect to the dimension of the aggregate in order to avoid the influence of the construction process. Consequently, the most feasible hypothesis is superficial degradation.

The results of density for each of the cores [Figs. 4(d and e)] indicate that no clear correlation exists between the location of

Fig. 4. Variation with the depth: (a) bulk density (BD); (b) apparent density (AD); (c) porosity (P); variation for each core: (d) bulk density (BD); (e) apparent density (AD); (f) porosity (P)

the core in the dam and the variation of density. For example, the cores located near the abutments (S3 and S6), in areas where infiltrations occurred, exhibit similar apparent densities to the cores that are located farther from the abutments (S4 and S5). The differences detected in such cases seem to be associated with the change of concrete type instead of the location in the downstream face.

The results of Fig. 4(f) corroborate the observations derived from the density analysis. Once more, the variations are not attributed to the location of the cores but rather to the composition of the concrete, i.e., the type of binder. Furthermore, smaller porosities were obtained for the concrete with portland cement [CP (250)]

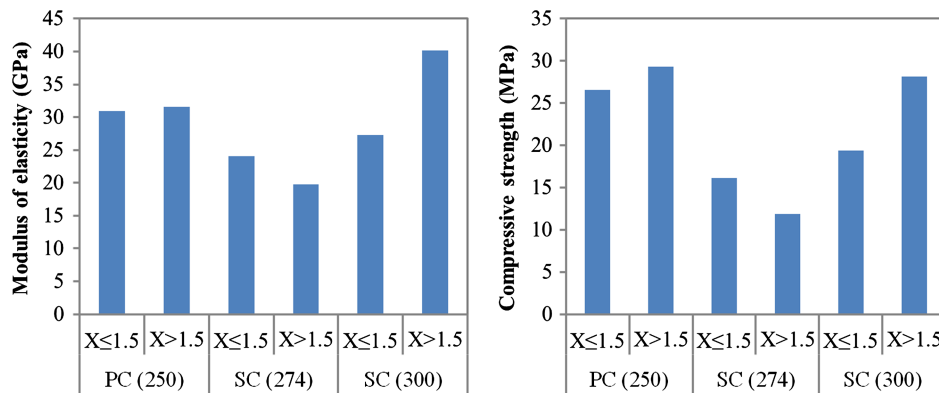
Fig. 5. Variation with the depth: (a) modulus of elasticity; (b) compressive strength

Fig. 5 presents the results of the modulus of elasticity and the compressive strength depending on the depth and the type of concrete. The values correspond to the average of the samples in the superficial areas and in the internal area. The dosages PC (250) and SC (300) exhibit an increase in the compressive strength in the internal layer, which is consistent with the results of density and porosity. Taking into account that the material should be

homogeneous in the studied zones, the variation observed may indicate a degradation process that is more evident for the sand-cement dosages than the portland cement dosages.

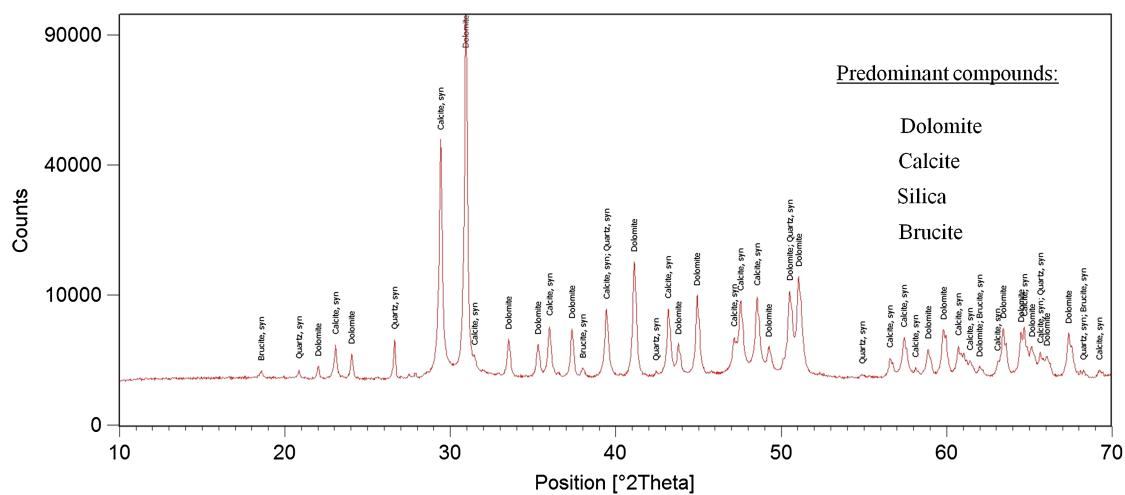
The samples extracted from the different cores were characterized by X-ray diffraction (XRD) analyses in order to assess the presence of crystalline compounds and identify them. The selected samples correspond to those that evidenced degradation of the cement paste, green halos around the aggregates, and crystallization zones. Fig. 7

shows the diffractogram obtained in a sample from core S3 and the predominant compounds found include dolomite, calcite, quartz, and a minor presence of brucite.

The remaining samples analyzed with XRD present similar results. Only a small amount of brucite was found, which is one of the main products of the dedolomitization reaction, and in such cases it was found in internal samples and never in the aggregate-matrix interface area. This phenomenon indicates that the brucite was already present in the aggregate before the concrete was produced.
